ANALYSIS OF FACADES

Leo G.W.Verhoef Techn.Univ.Delft, Dep.of Architecture

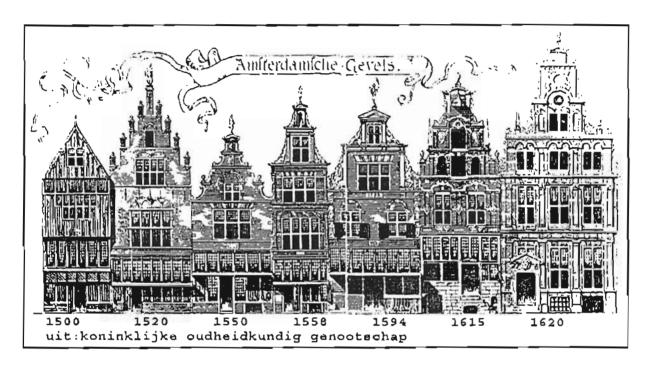
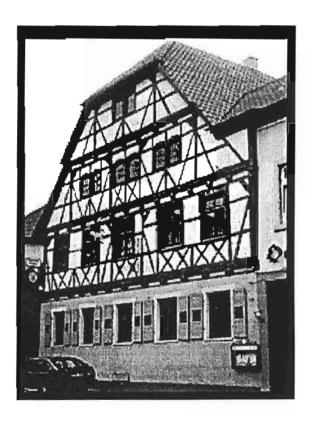
We see the "spout" gable with its slanting surface causing water to be diverted from the horizontal shoulder areas (for the same reason, additional structures to the sloping parts of Gothic buildings distributed the flow of water), and the "step" gable with its horizontal covering, although the seam between the protected horizontal brickwork and the vertical brickwork was rather vulnerable; the later "scrolled" gable, "neck" gable and "corniche" gable dealt more effectively with this problem.

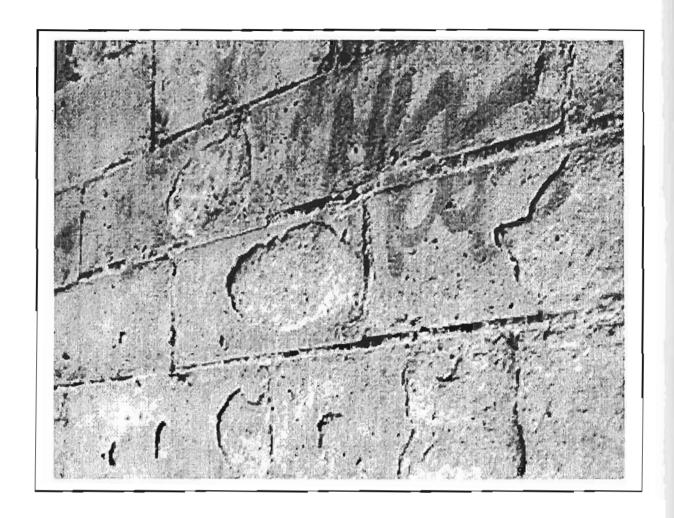
The analysis of a facade can also give information over the history of the building and the facade itself. Buildings are subjected to many changes. They are altered, enlarged and renovated. Stones are replaced which causes the moisture management to change. Furthermore, joints are cleared out and repointed with cement mortar joints instead of the original lime mortar. Rainwater falls onto the stones and is absorbed by them. Under the law of gravity the water should then settle into the joints but they are now impermeable. It can often be observed how an unsaturated piece of stone is frozen out of its impermeable joints.
