THE USE OF POLYURETHANE IN SURFACE TREATMENT

Prof.Dr. Mihály Zádor and Dr. György Kollár
University of Budapest

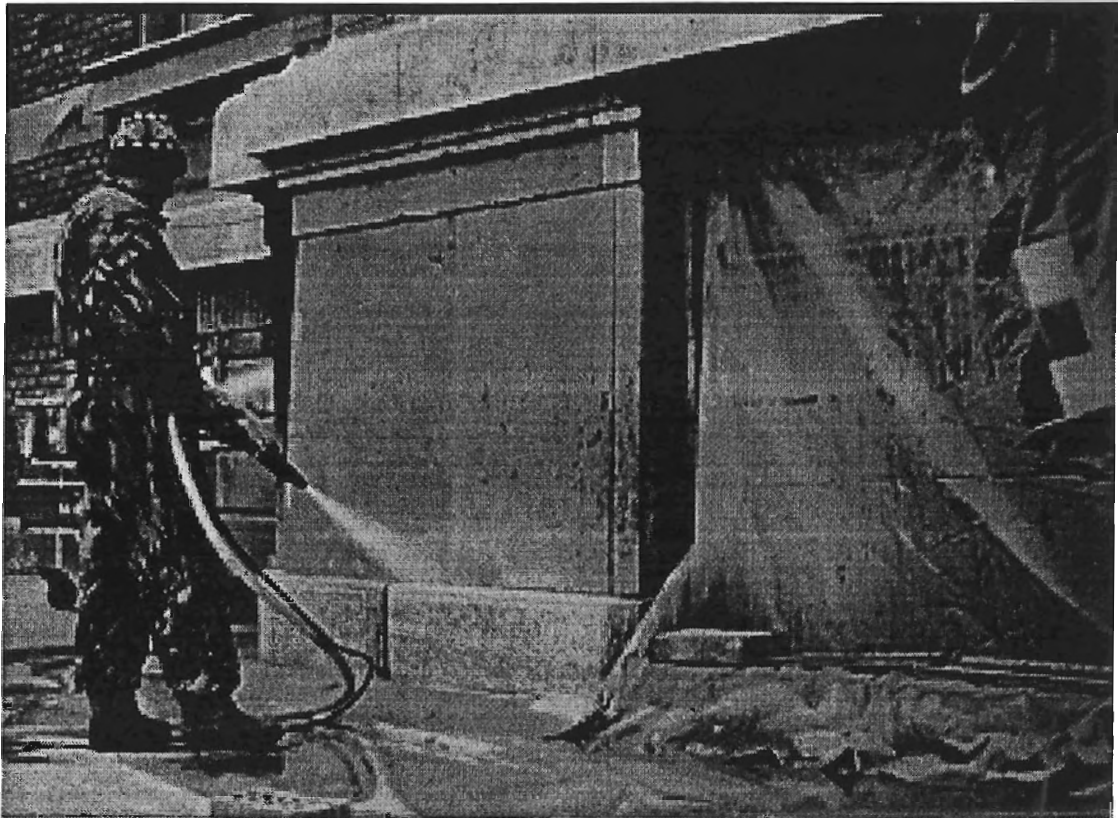
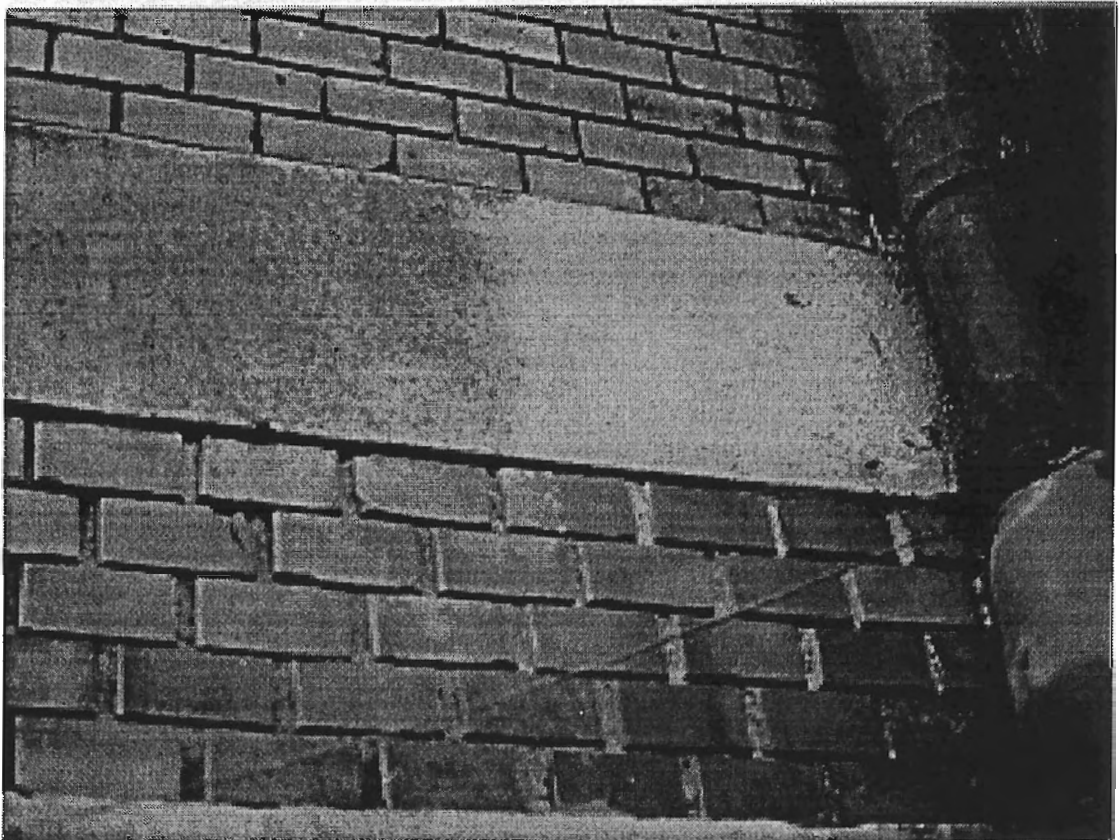
PHOTO 4.a, b The most popular less destructive cleaning method in Hungary (J.O.S. method).

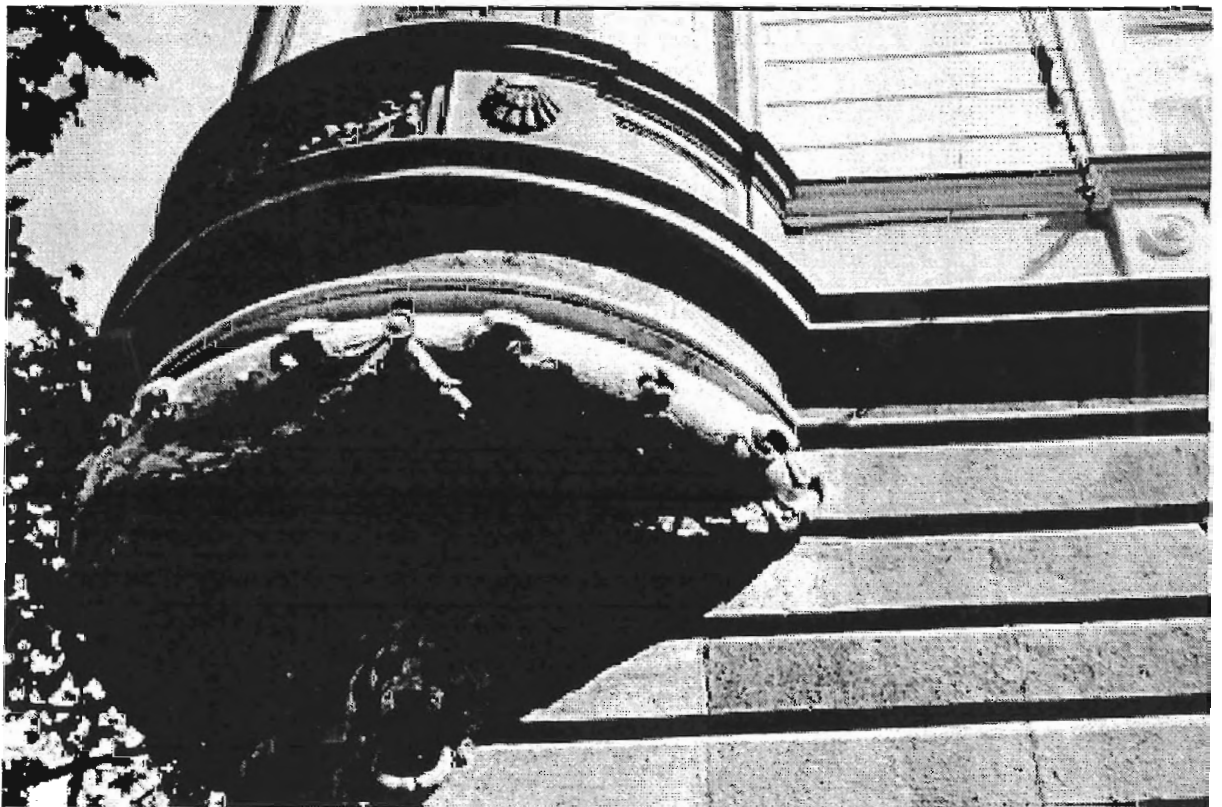
PHOTO 9 A special way of using our Hungarian polyurethane treatment for different kind of materials on the same facade (e.g. fixing the deteriorated plaster, stone and brick construction etc.,) by capilair transport from the polyurethane through the seperated layer and fixing to the brick wall behind.

our most complex task to date was the restoration of the facade of Brunswick Castle in Martonvásár. Here, our stone conservation method could be tested on a facade made up of a multiplicity of materials (stone, brick and painted plastering, which was applied on facades particularly at the turn of the century). In addition to conserving the stone and pyrogranite, the original plastering had to be preserved. Firstly, the plastering, comprising two layers 3 to 5 cm thick, was fastened to the wall with ZKF, then painted. This initiated another study - to find a paint which could be applied to ZKF-treated plastering;
