Water-Repellent Silanes Protect the Concrete Ceiling of the Gotthard Road Tunnel

D. Auer, R. Minery, L. Gollwitzer and J. Ihringer

Wacker Chemie AG, Burghausen

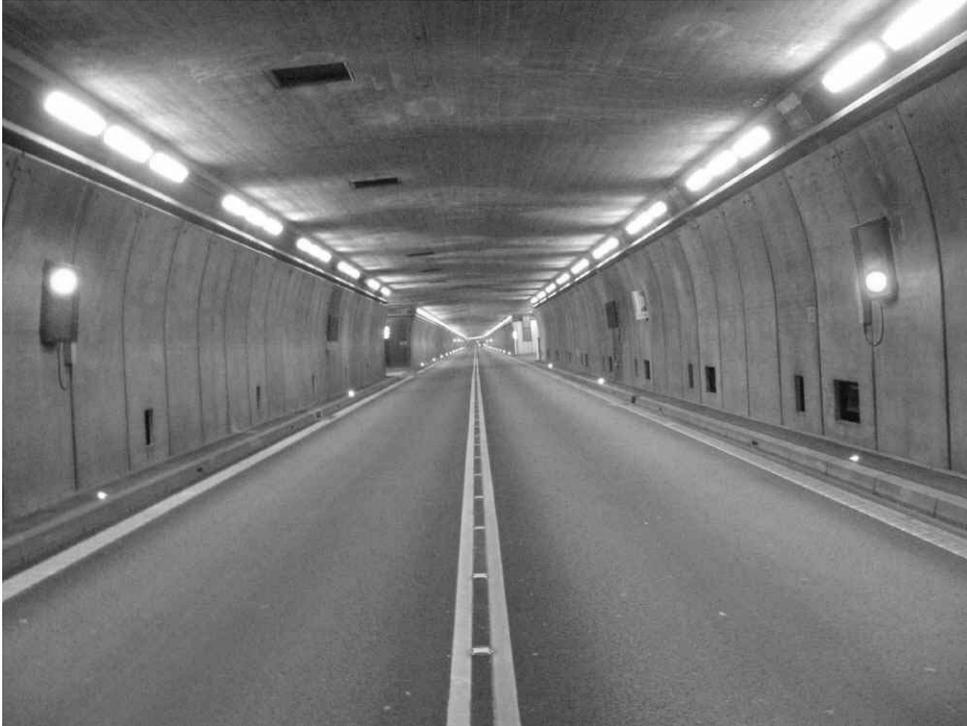
Figure 1: Tunnel roof after the cleaning and concrete repair work

The first step was to clean the suspended ceiling in the entrance area at both ends of the tunnel. All dirt was hydrojetted off with water pressure between 280 to 520 bar. Gravel nests, steel reinforcement close to the surface, and other imperfections in the ceiling were marked and retreated with a special hydrojetting method that uses a water pressure of about 2500 bar.

The next step was to replace the missing concrete. After application of a protective coating to the exposed reinforcement, repair mortar was sprayed onto the open areas and then smoothed over. The quality of the finish was checked after the concrete had hardened by testing the pull-off

strength of the mortar at selected points. Since penetration of the silane cream depends on the quality of the concrete substrate, a few test areas were treated with the cream.

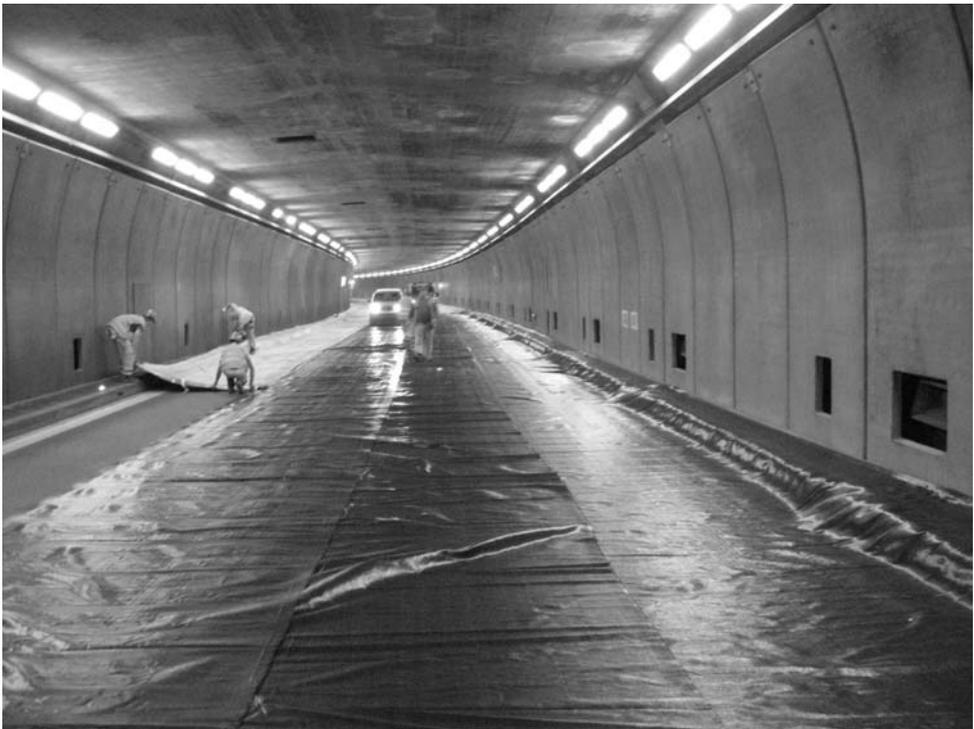
Figure 2: Unrolling the matting to cover the road inside the Gotthard tunnel

With all the precision of a Swiss watch, the repair gangs swung into action. As soon as the last truck had exited, some two dozen workers dressed in protective clothing and high-visibility jackets began “Operation Gotthard” at both entrances. First, painters and concrete repair specialists covered the entire roadway with special matting using unrolling equipment. In three hours, they covered 7,000 square meters of road at both ends. The spray mist containing the silane cannot be allowed to get onto the road surface because that would make it slippery and cause drivers serious problems. In addition, traffic signals and measuring equipment had to be protected against the spray.

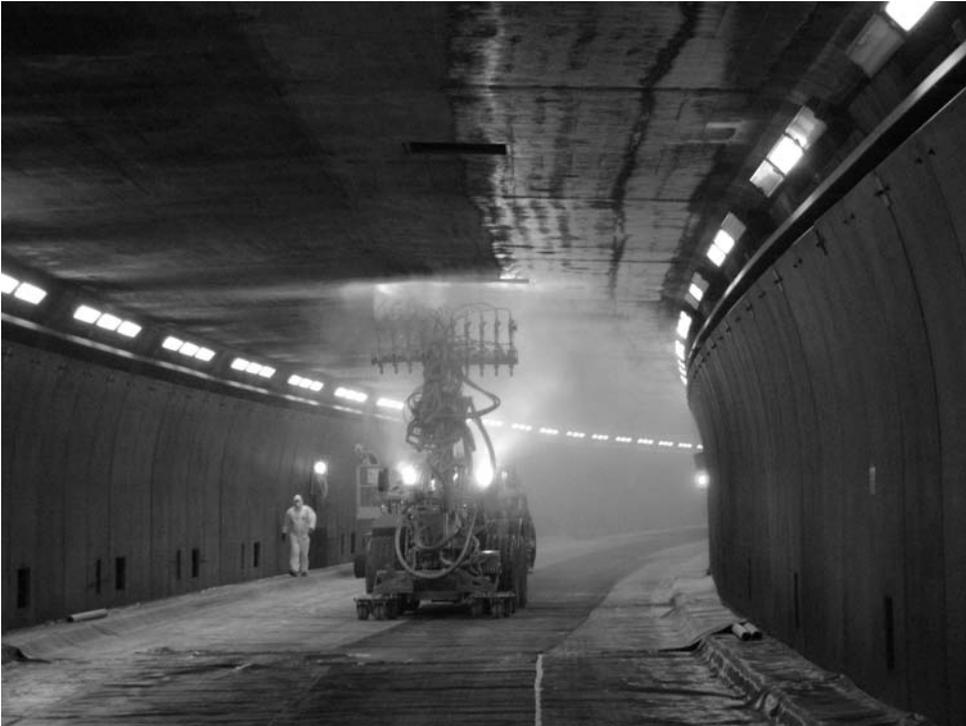
Figure 3: Multinozzle sprayer in action

After everything had been covered, the high-tech spray guns at each end of the tunnel got to work: these automatic sprayers traversed the 750 meters of tunnel in two passes. The multiple nozzles covered the roof with about 330 grams of material per square meter. Because it is a paste, it can be applied much more thickly. The cream adheres to the surface better, and that enables more of it to penetrate into the concrete. The silane cream has a long contact time and is designed to ensure maximum penetration of the concrete by the active ingredient. The depth to which the waterproofing agent penetrated the concrete was examined by materials experts during quality control measures after the treatment. The goal of deep impregnation with the silane cream ingredients is to penetrate to a depth of about six millimeters, to provide a water-repellent lining within the concrete pores and to keep out saltwater.
